BUREAU OF SHIPS GROUP TECHNICAL INSPECTION REPORT

OPERATION CROSSROADS. U.S.S. INDEPENDENCE (CVL22)

TEST ABLE

VOLUME 1 OF 4 [U].

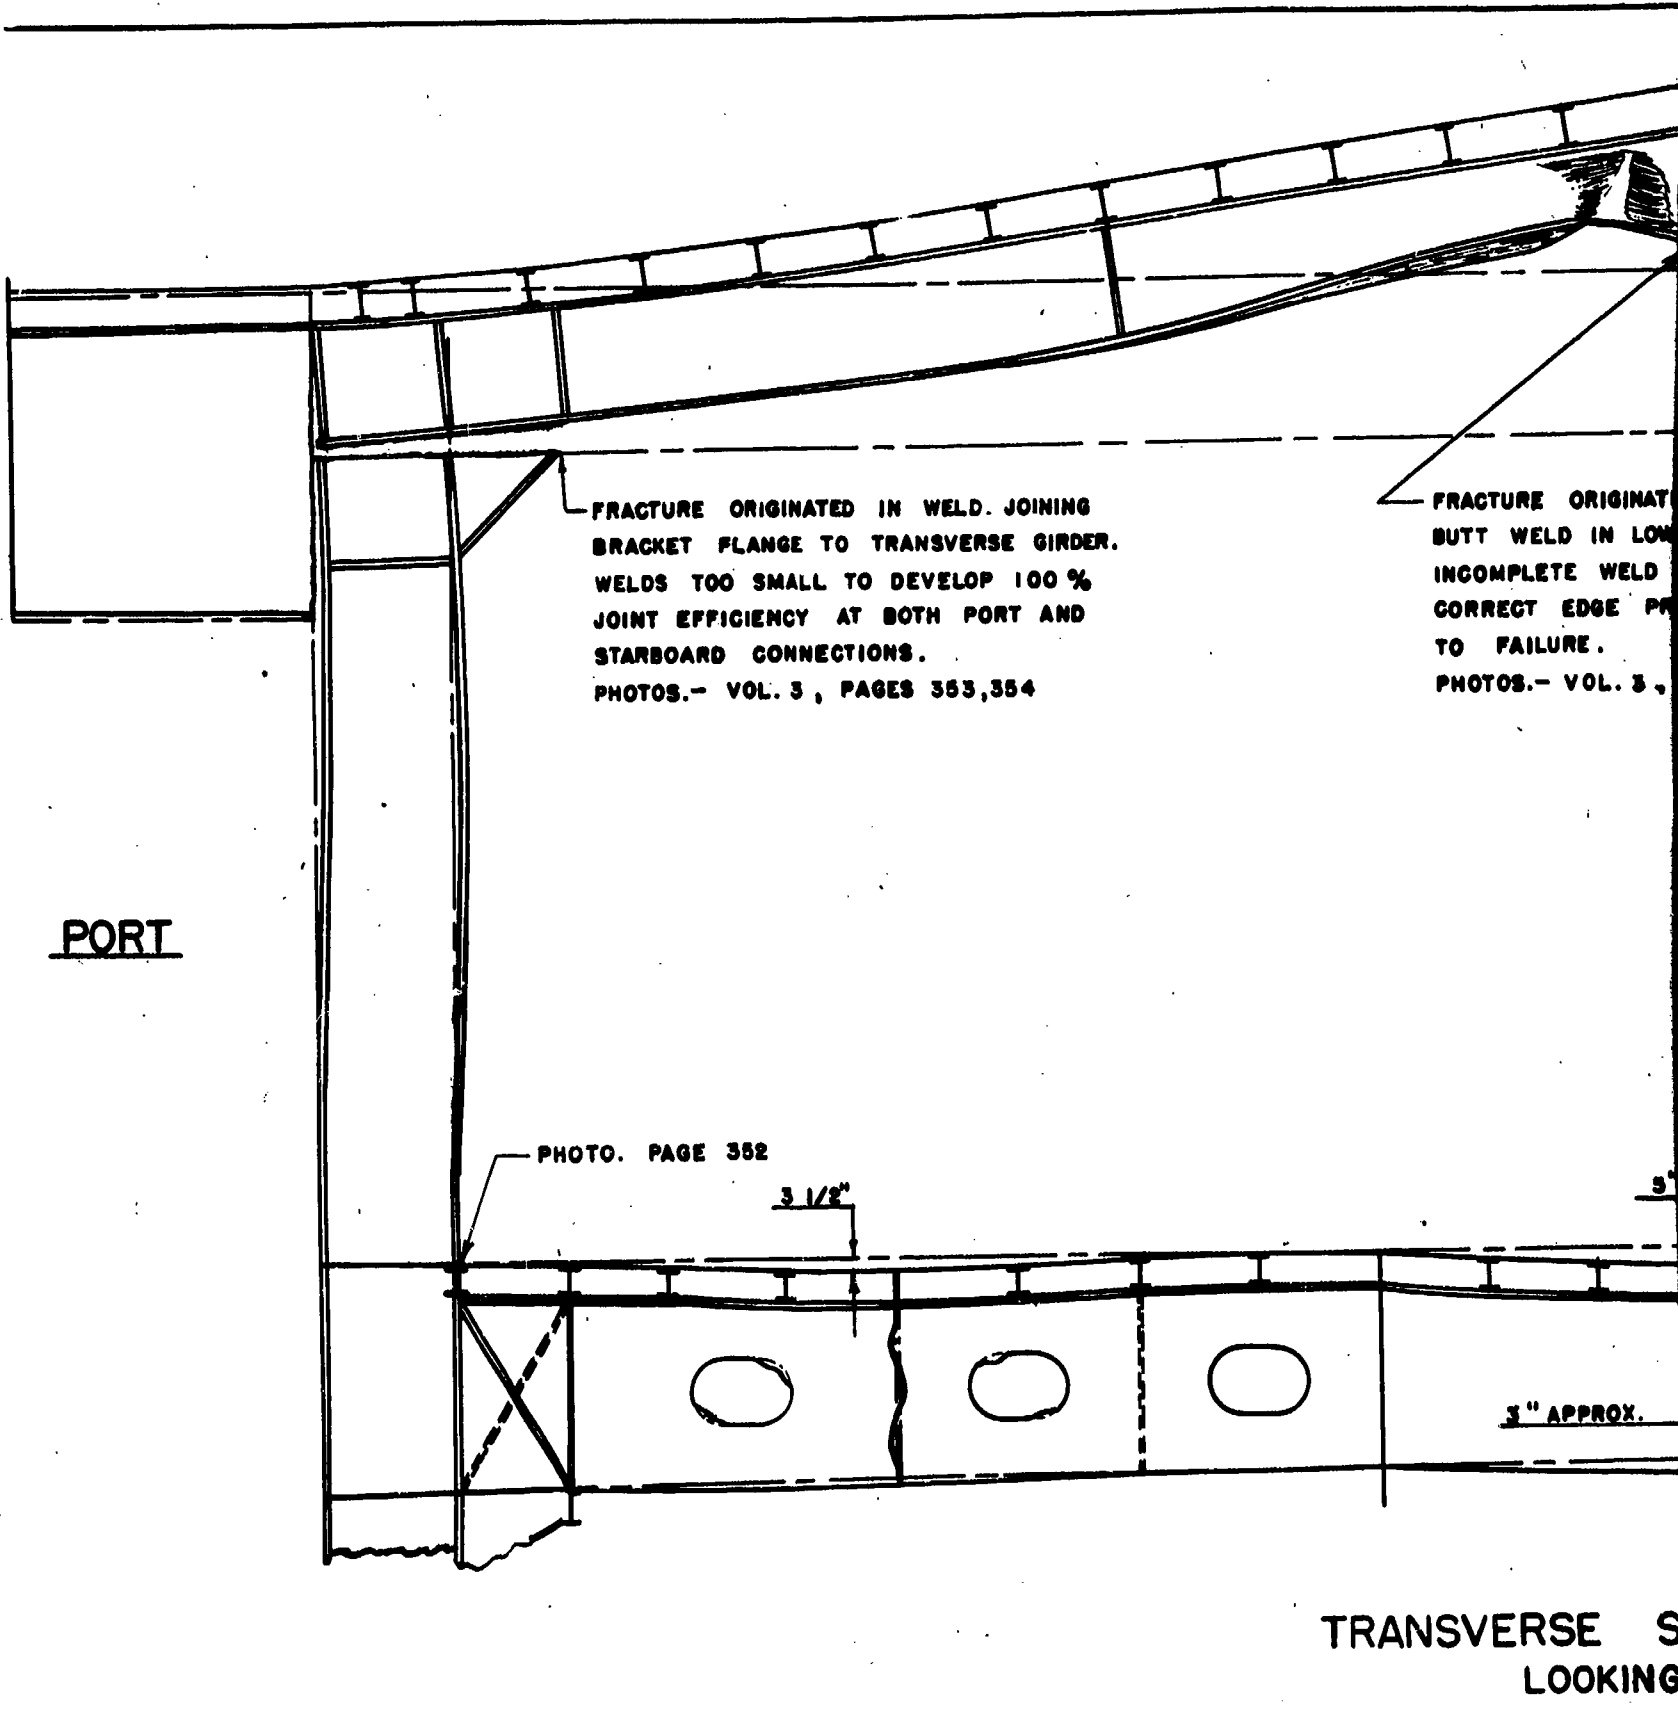
FRACTURE ORIGINATED IN WELD JOINING
BRACKET FLANGE TO TRANSVERSE GIRDER.
WELDS TOO SMALL TO DEVELOP 100 %
JOINT EFFICIENCY AT BOTH PORT AND
STARBOARD CONNECTIONS.
PHOTOS.- VOL. 3 , PAGES 353,354

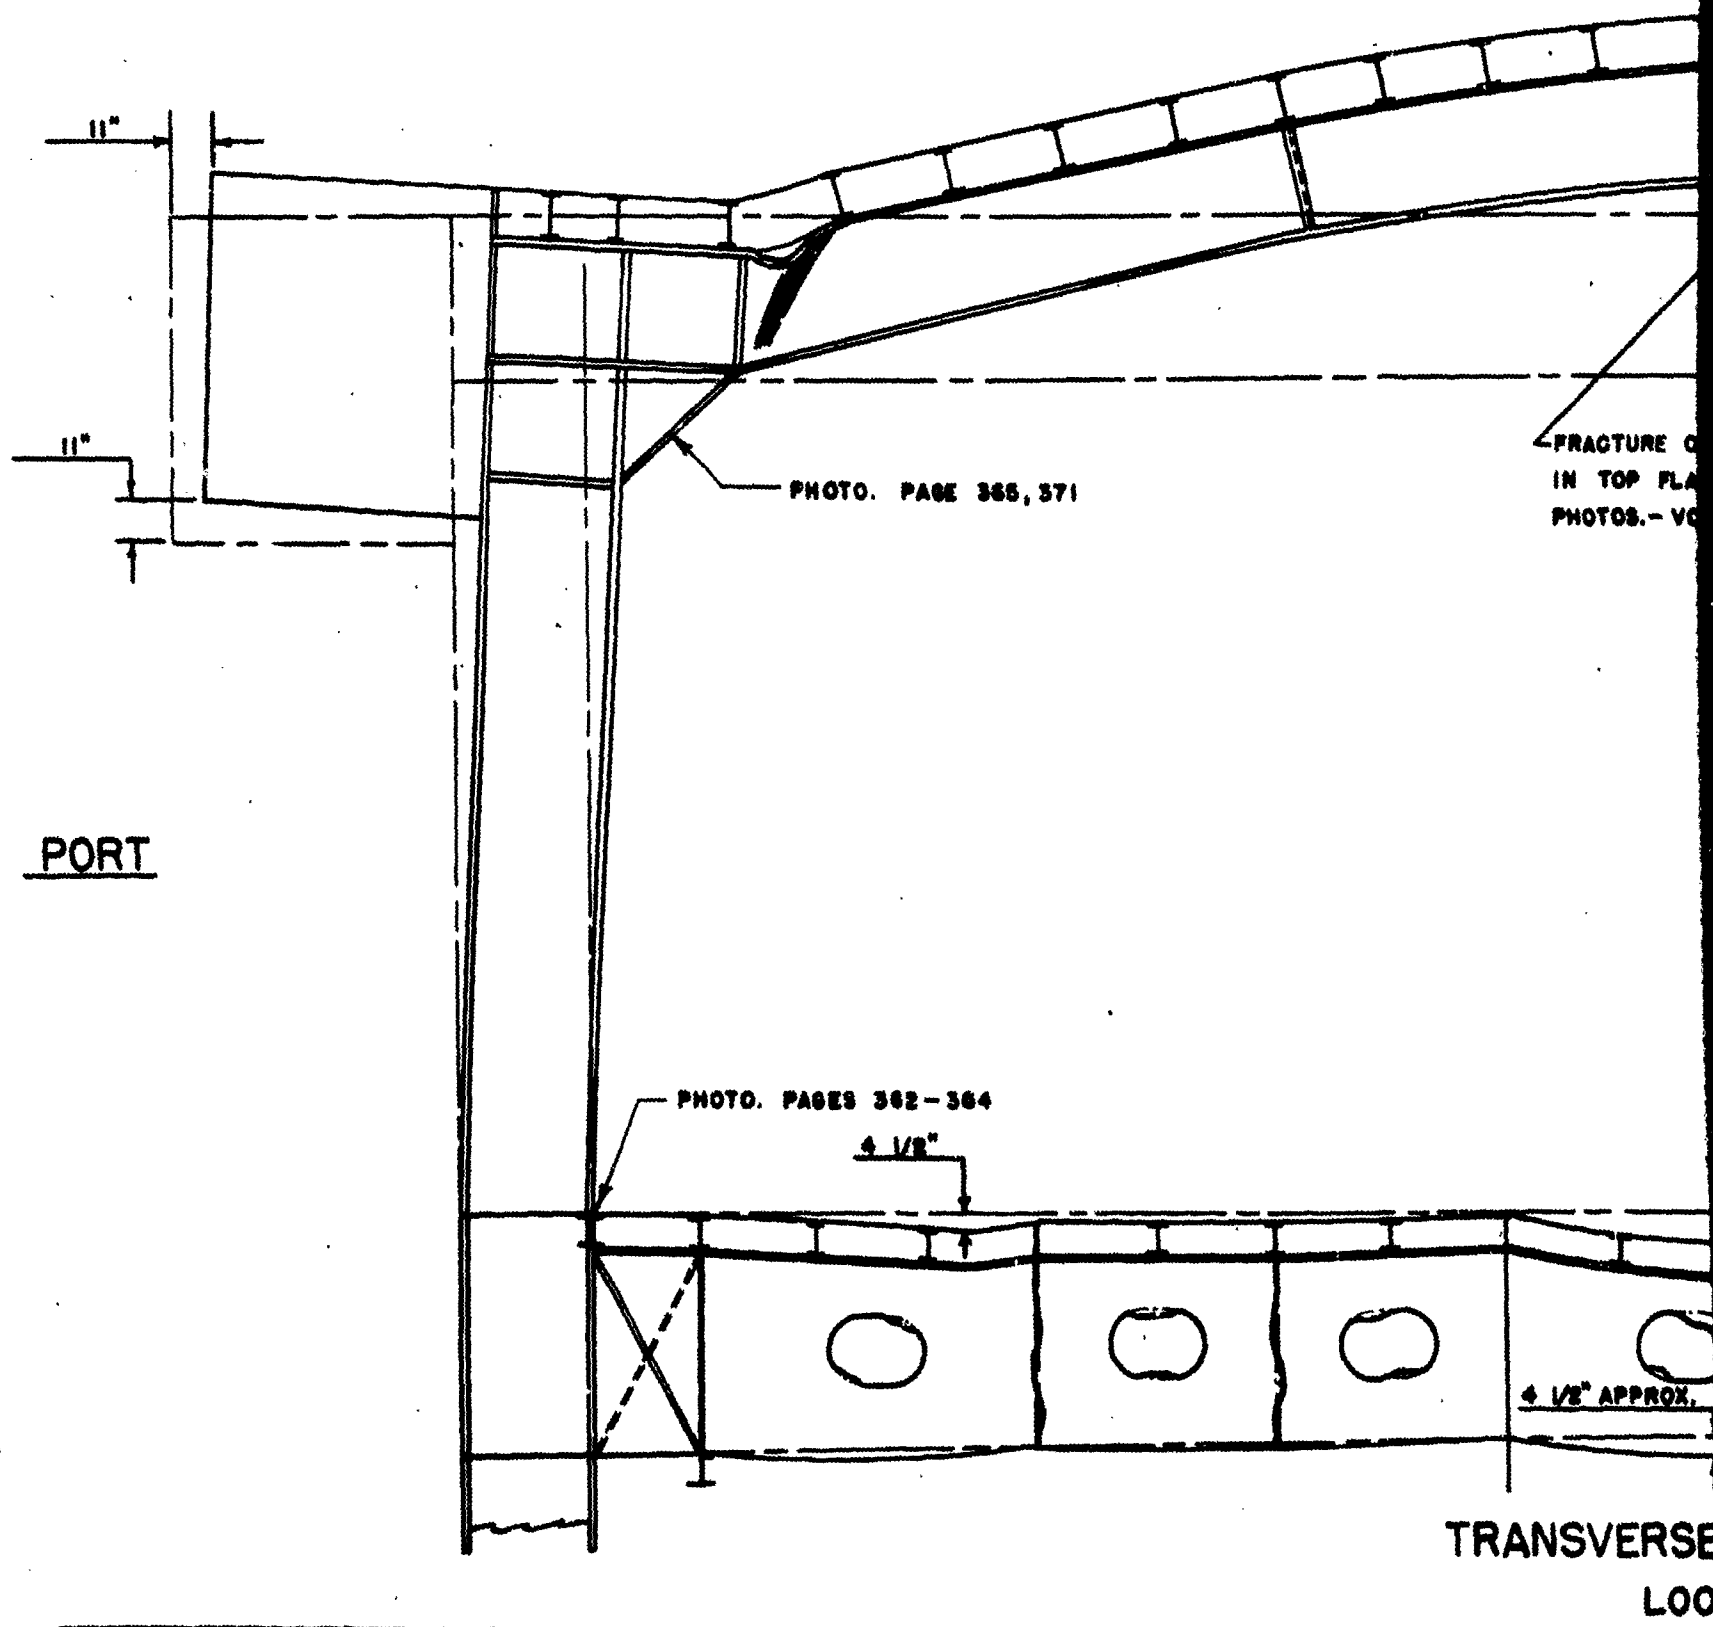
FRACTURE ORIGINATED AT EDGE OF WELD
 IN TOP FLANGE OF GIRDER.
 PHOTOS.- VOL. 3, PAGES 366-369, 375, 376

FRACTURE ORIGINATED AT UPPER EDGE
 OF WELD JOINING GIRDER AND
 BRACKET FLANGES.
 DISCONTINUITY IN STRUCTURAL DESIGN
 OF CONNECTION CONTRIBUTED TO FAILURE.
 PHOTOS.-VOL. 3, PAGES 370, 372

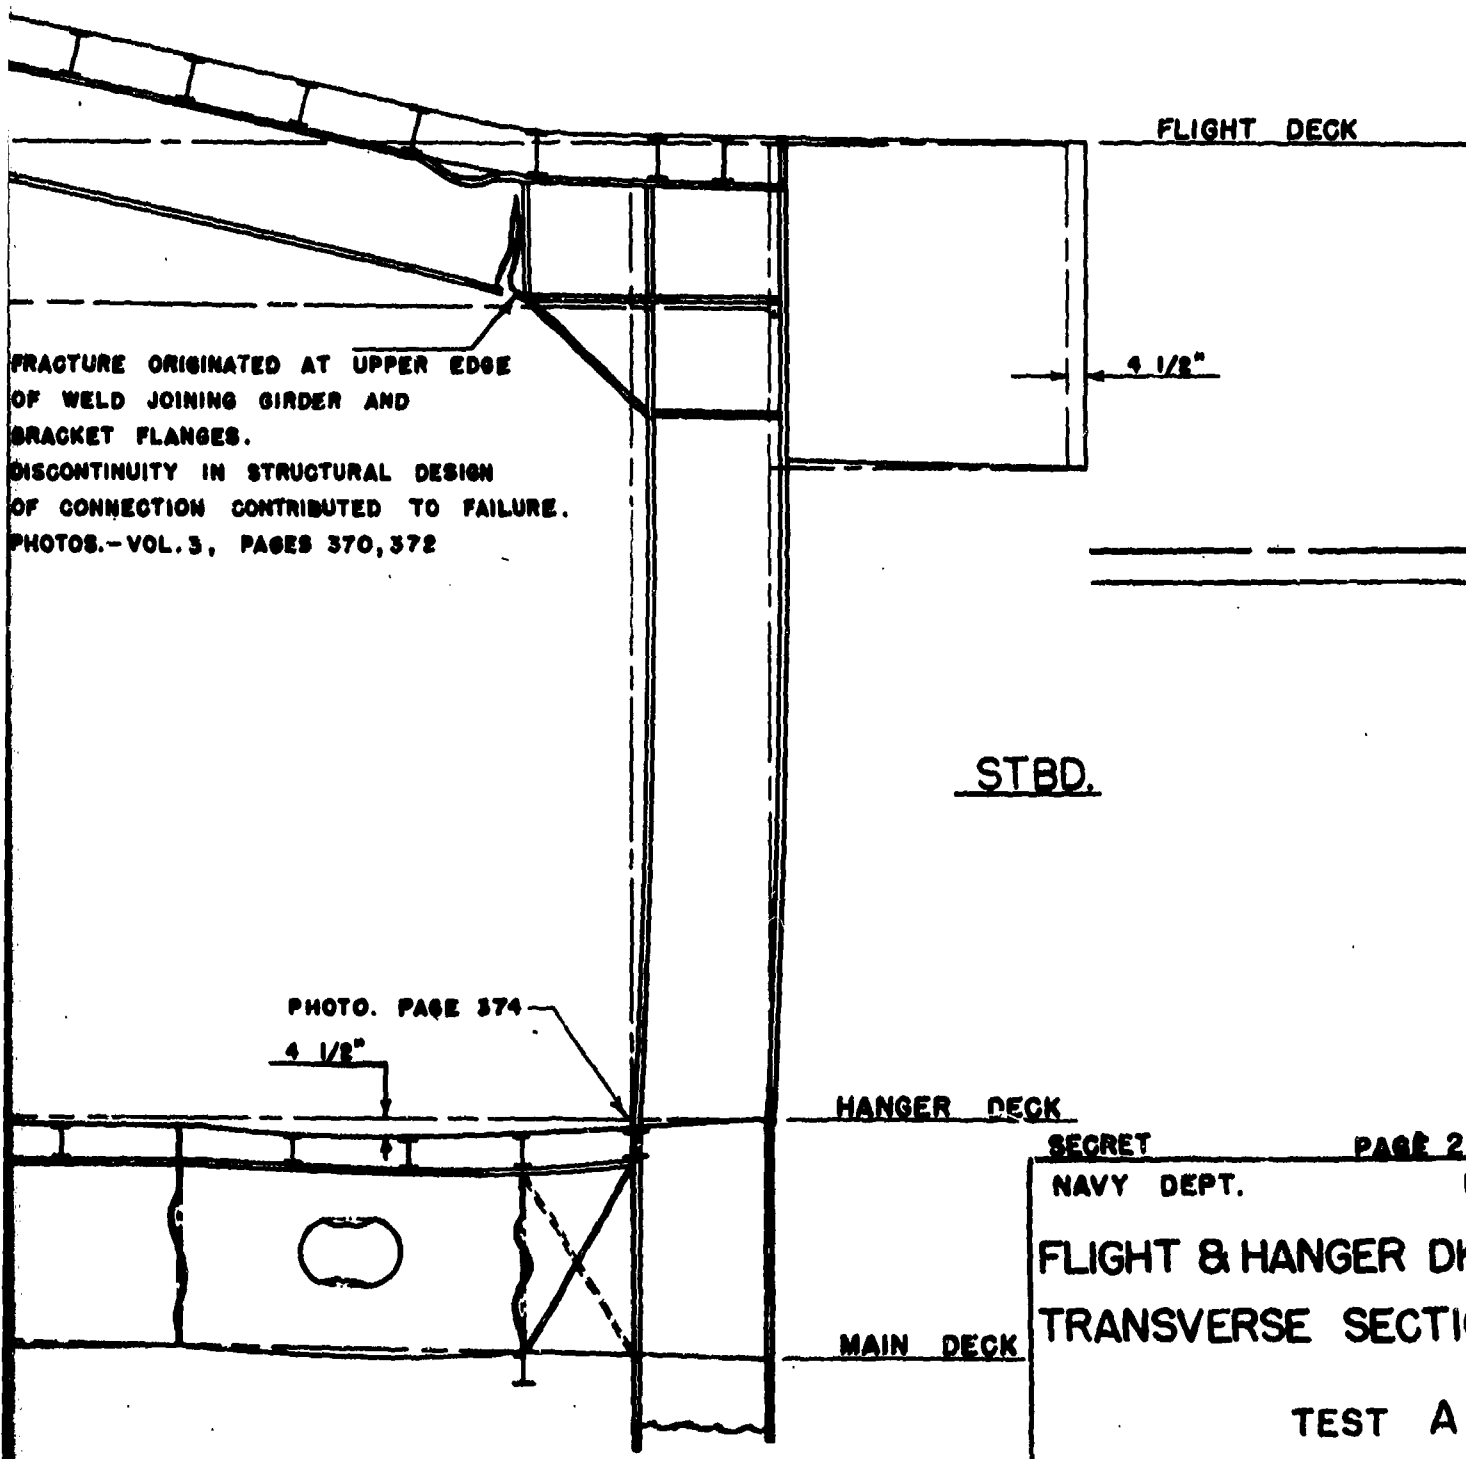
TRANSVERSE SECTION AT FR. 74
 LOOKING FORD.

FRACTURE ORIGINATED AT UPPER EDGE
OF WELD JOINING GIRDER AND
BRACKET FLANGES.
DISCONTINUITY IN STRUCTURAL DESIGN
OF CONNECTION CONTRIBUTED TO FAILURE.
PHOTOS.-VOL. 3, PAGES 370, 372

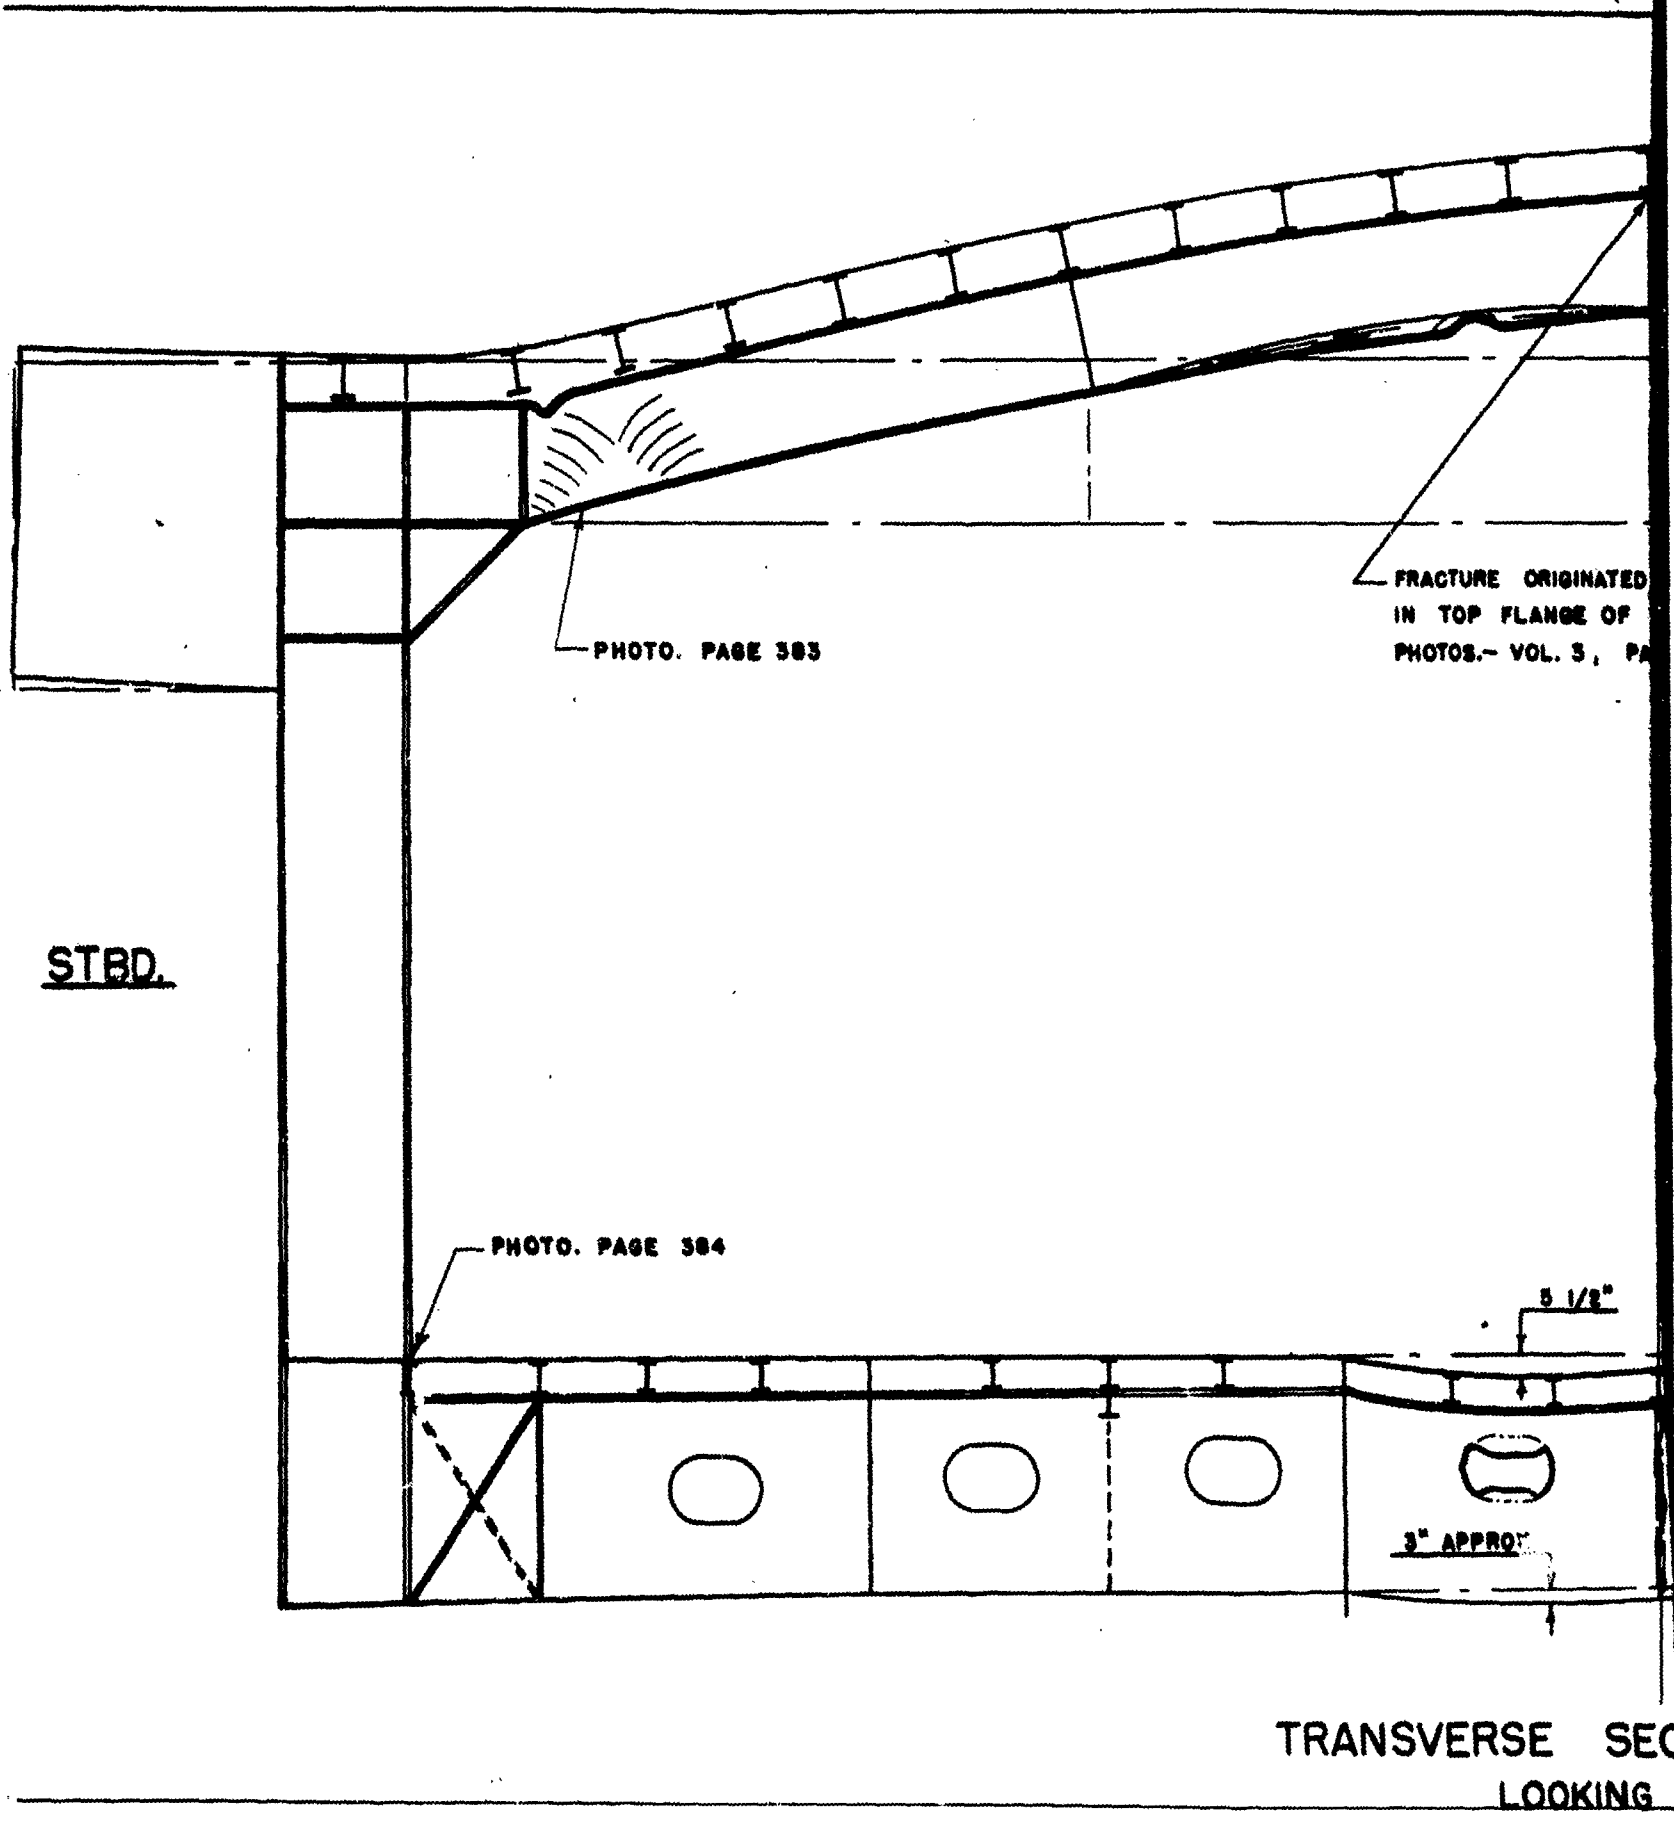
VERSE SECTION AT FR.77
LOOKING AFT.

RACTURE ORIGINATED AT EDGE OF WELD
TOP FLANGE OF GIRDER.

SLIGHT FRACTURE WITH ORIGIN AT UPPER
EDGE OF WELD JOINING COLUMN AND
BRACKET FLANGE.

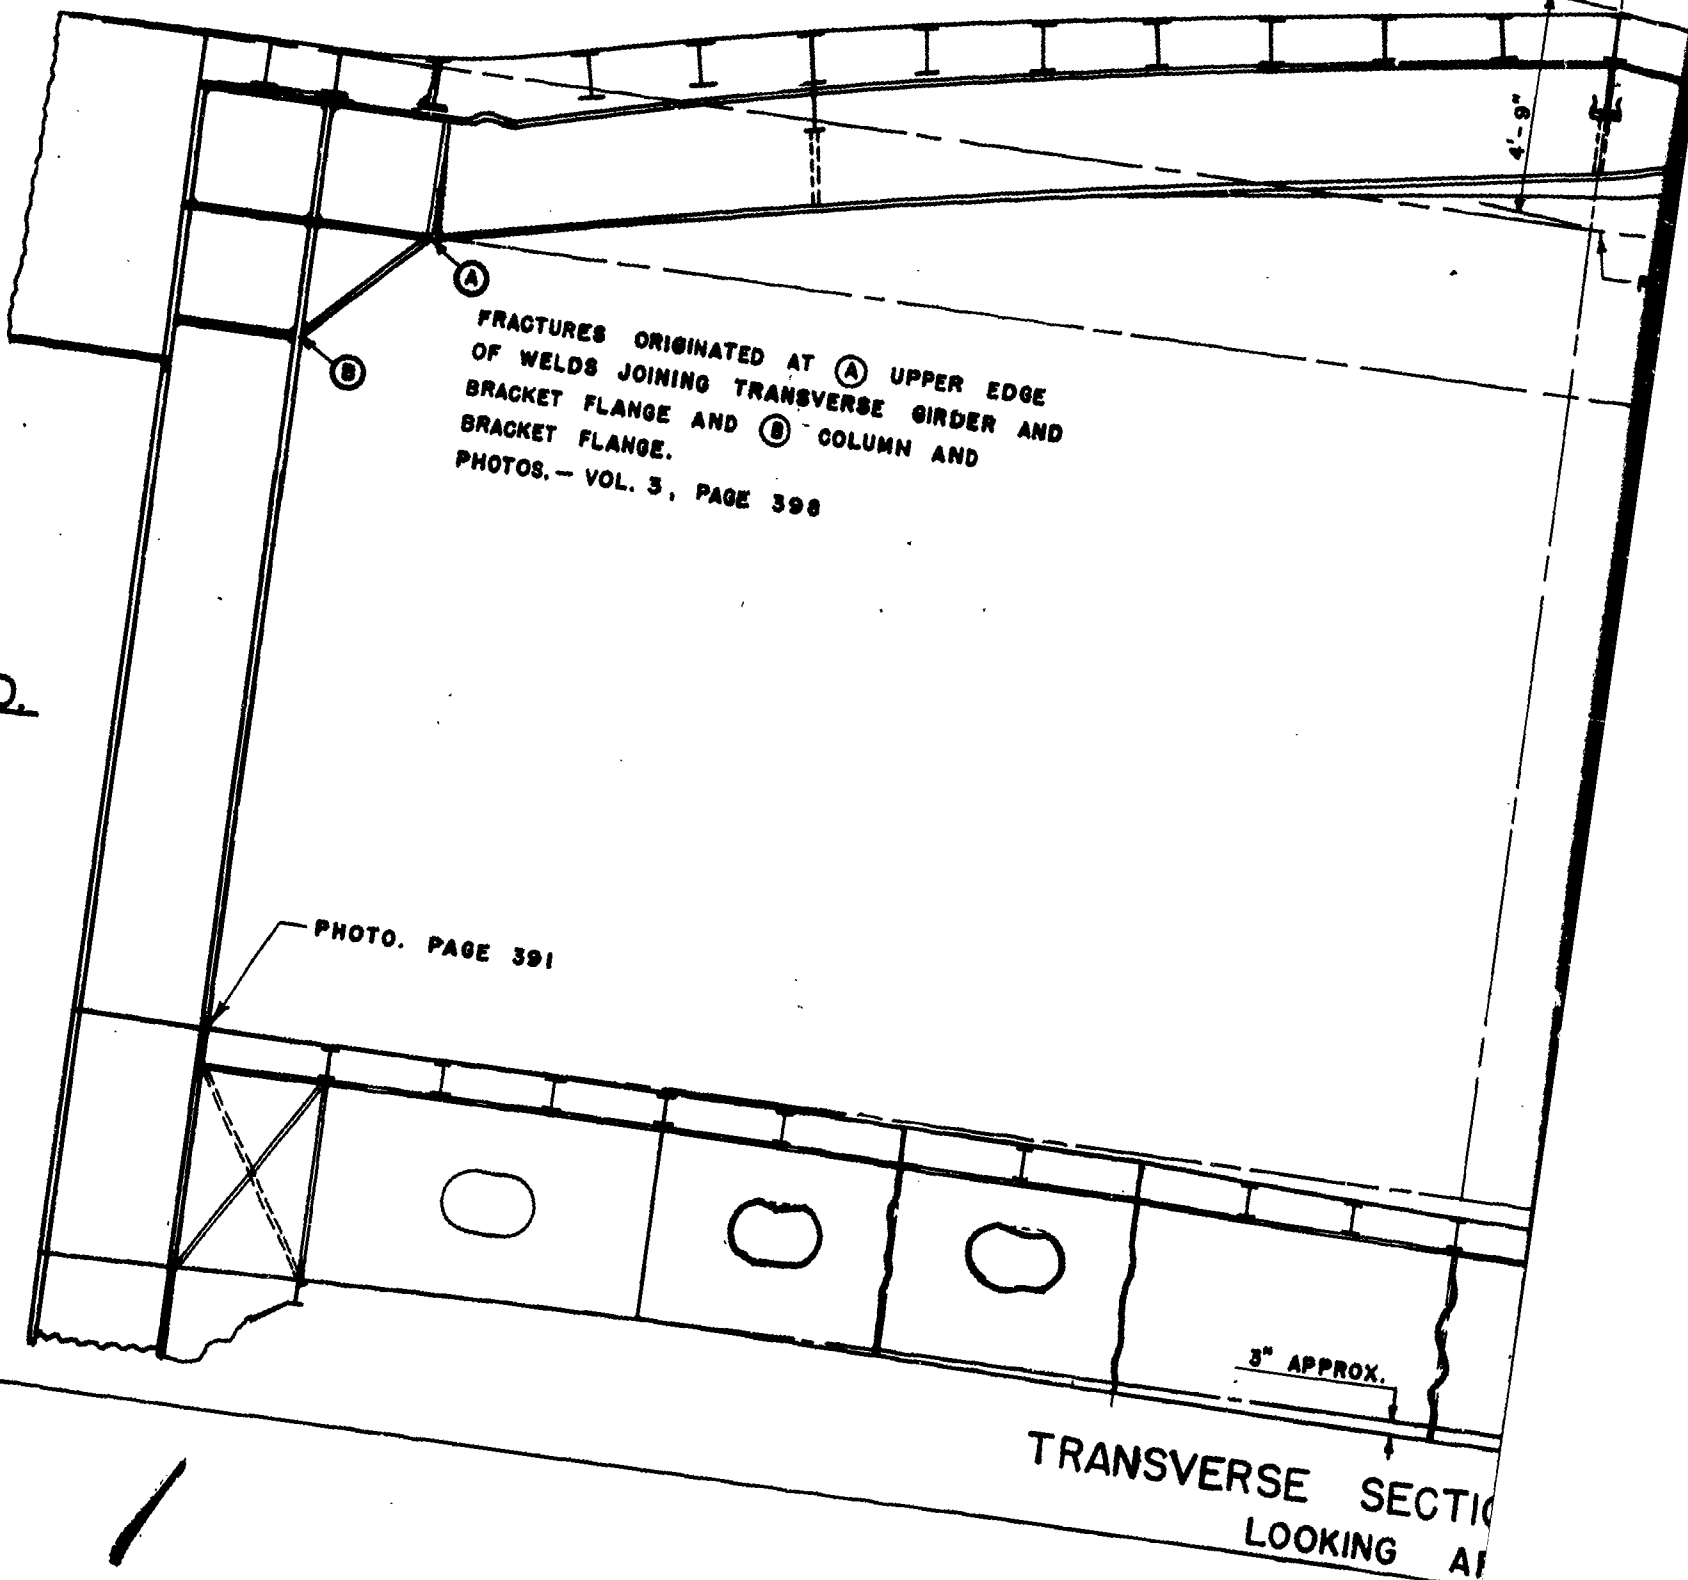
FRACTURES ORIGINATED AT (A) UPPER EDGE
OF WELDS JOINING TRANSVERSE GIRDER AND
BRACKET FLANGE AND (B) COLUMN AND
BRACKET FLANGE.
PHOTOS. - VOL. 3, PAGE 398

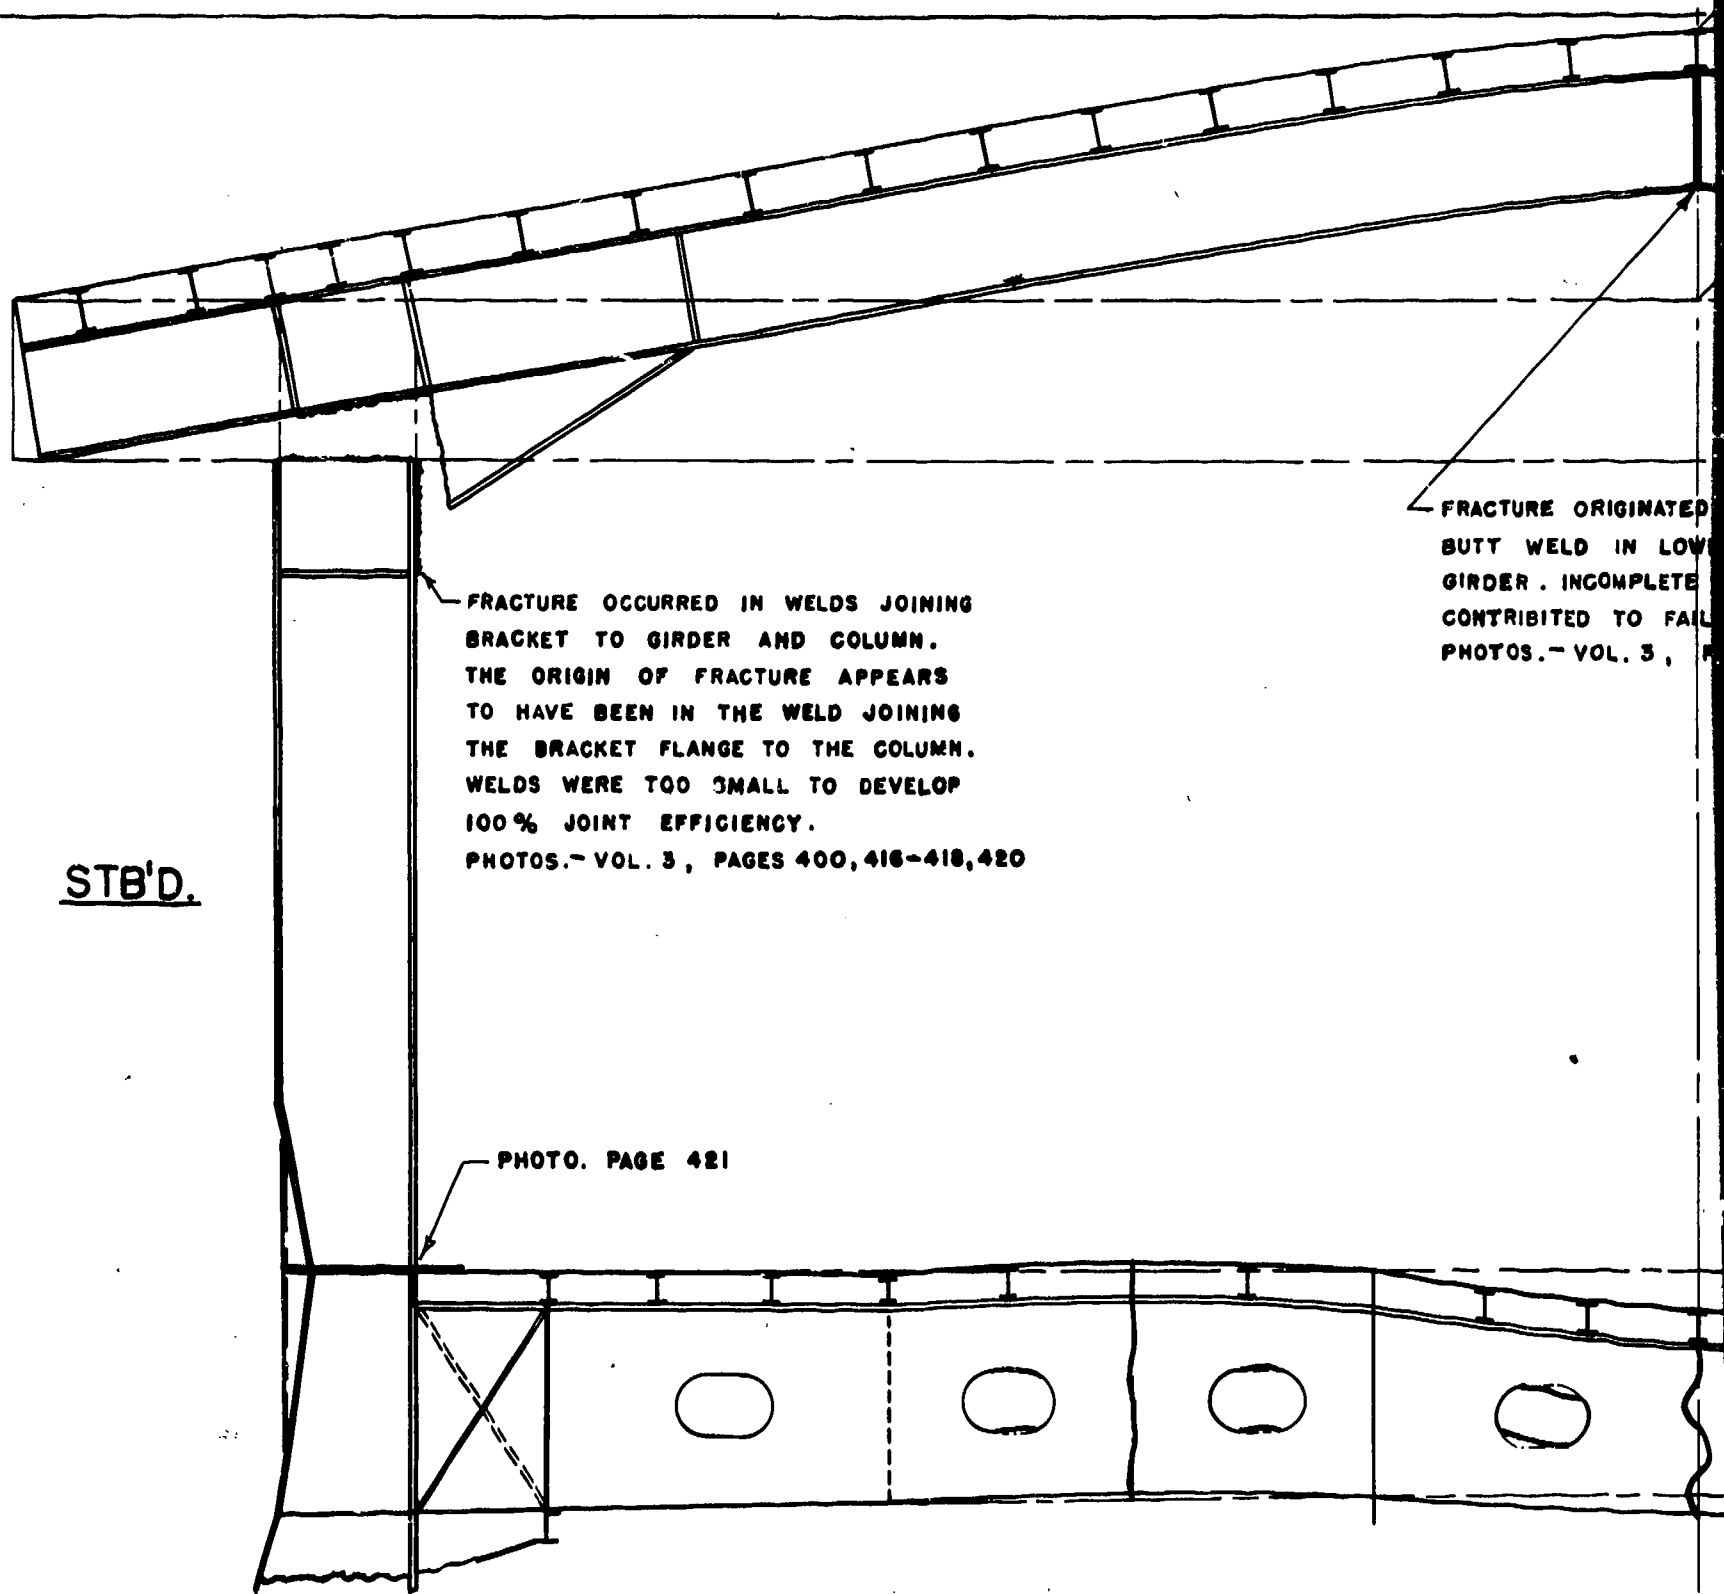
FRACTURE OCCURRED IN WELDS JOINING
BRACKET TO GIRDER AND COLUMN.
THE ORIGIN OF FRACTURE APPEARS
TO HAVE BEEN IN THE WELD JOINING
THE BRACKET FLANGE TO THE COLUMN.
WELDS WERE TOO SMALL TO DEVELOP
100% JOINT EFFICIENCY.
PHOTOS.- VOL. 3, PAGES 400, 416-418, 420

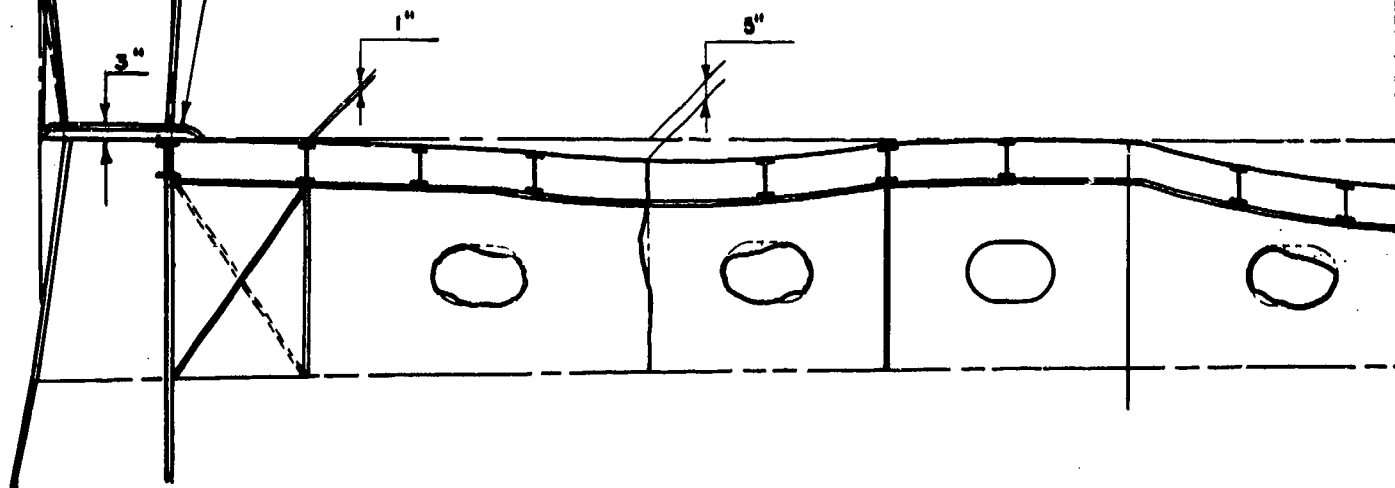
PULLED LOOSE FROM DECK AT
RIVETED CONNECTION.
PHOTOS.— VOL. 3, PAGES 436-438

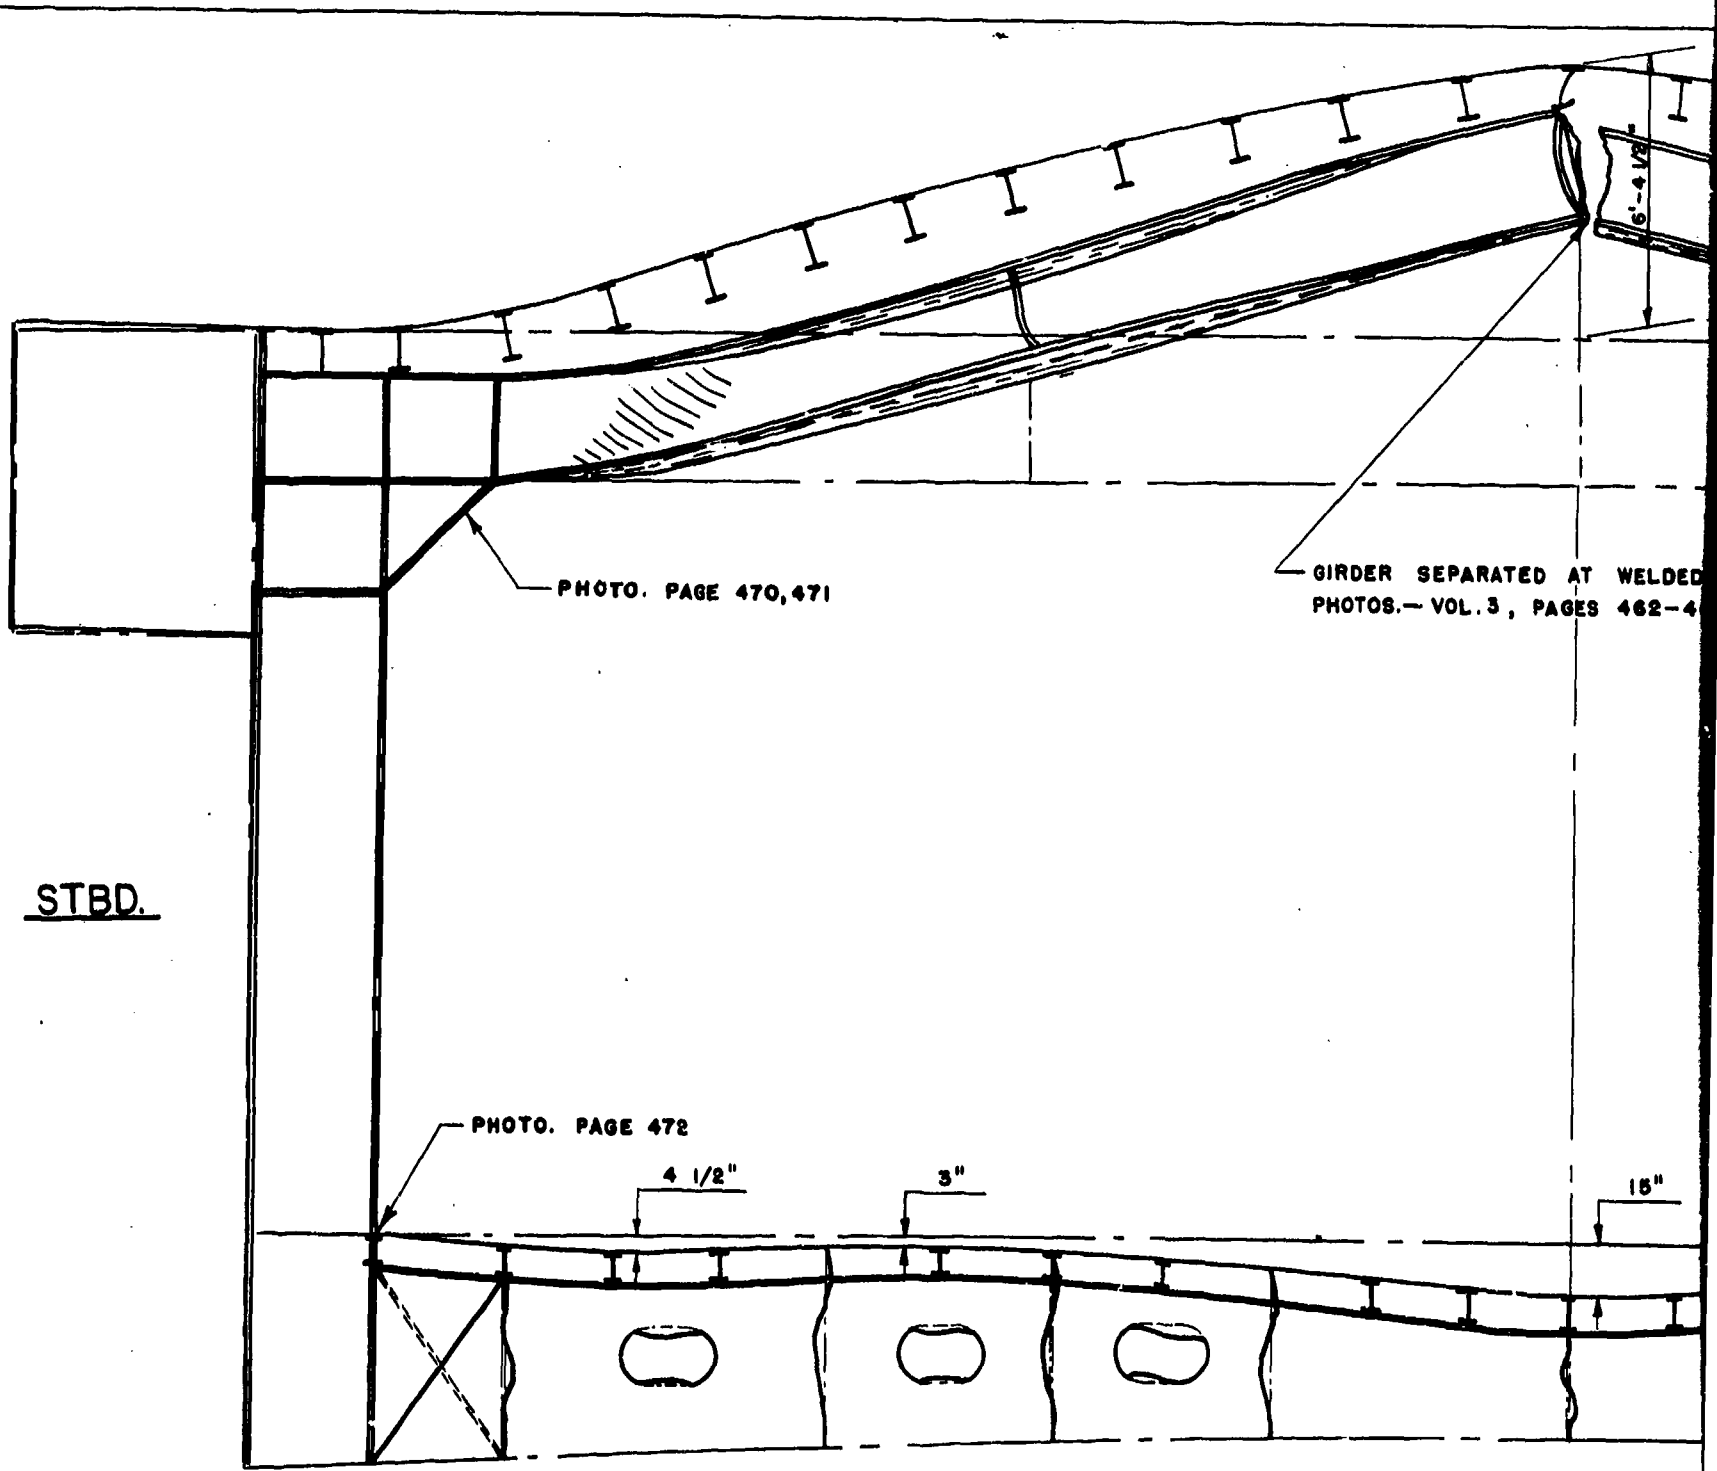
GIRDER SEPARATED AT WELDED
PHOTOS.— VOL. 3, PAGES 462-4
